Circuit Breaker Problems

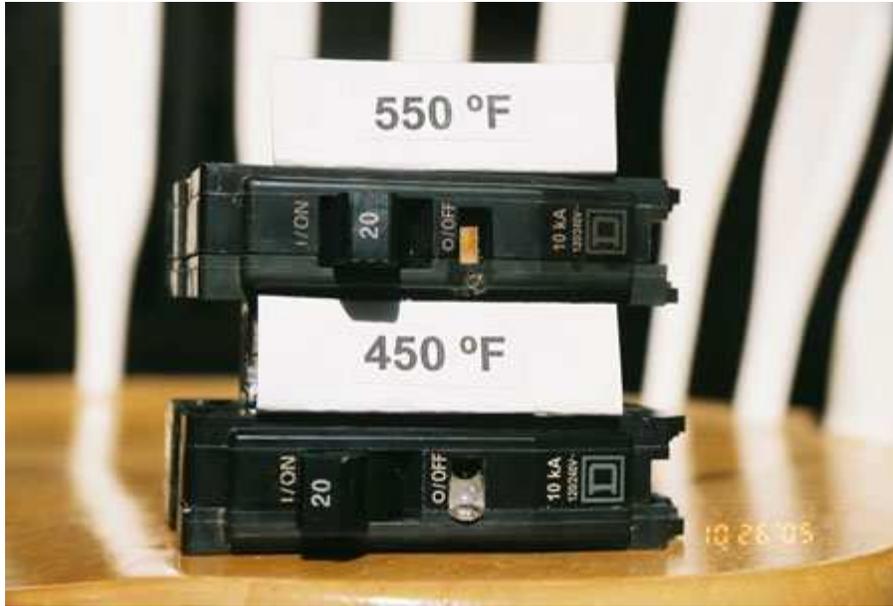
Two Square D Circuit Breakers were placed in an Oven.
The Lens melted at 450°F; the Breaker Tripped at 550°F.

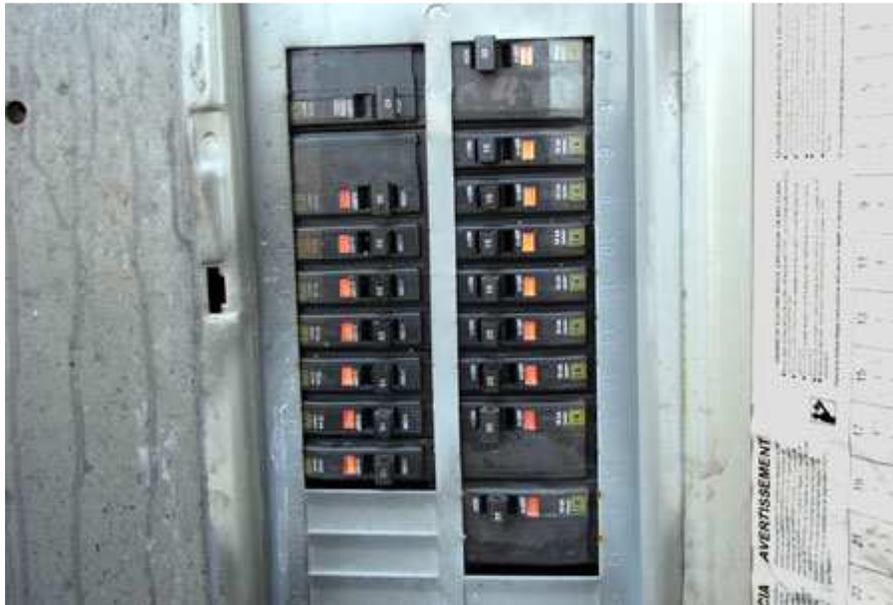
The Plastic Lenses are intact. The Circuit Breakers in this Panel tripped because of
Electrical Activity and not the Heat of the Fire.

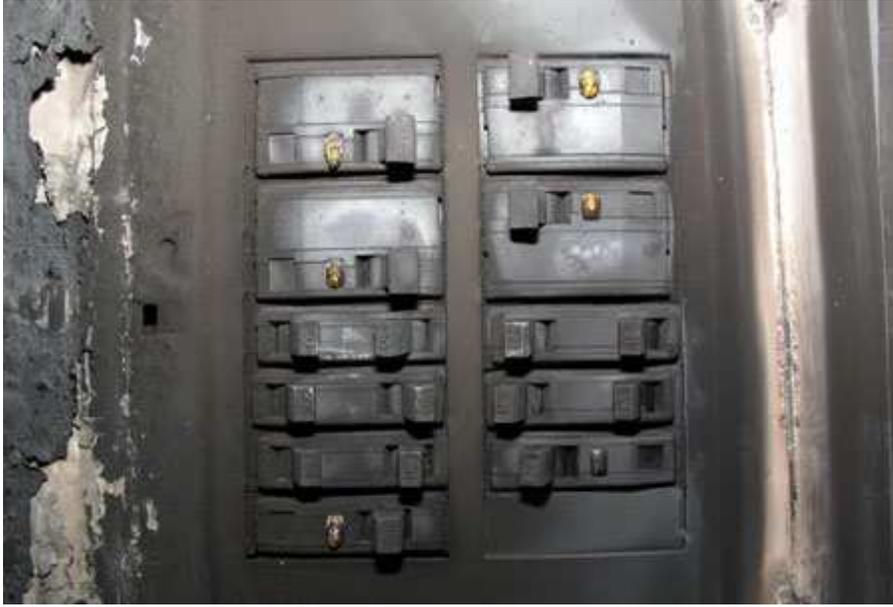
The Plastic Lenses in this Panel are starting to melt.
The Heat of the Fire could have tripped the Circuit Breakers.

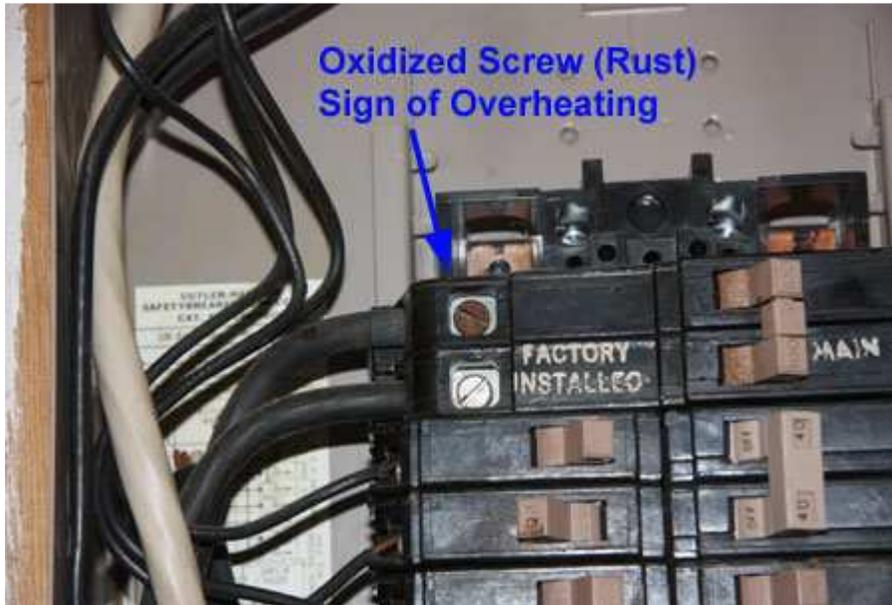
When a tree limb fell, there was structural damage to this homeowner's weatherhead and meterbase. After repairs were made, the homeowner complained that his lights were blinking and the dryer circuit breaker was tripping. The inside electrical distribution panel was directly behind the meterbase. It is possible that when the weatherhead moved, it pulled the conductors feeding the inside panel box; it is also possible that this problem existed long before the tree limb fell.

Heat on a Screw will cause it to Oxidize or Rust (F09-028).

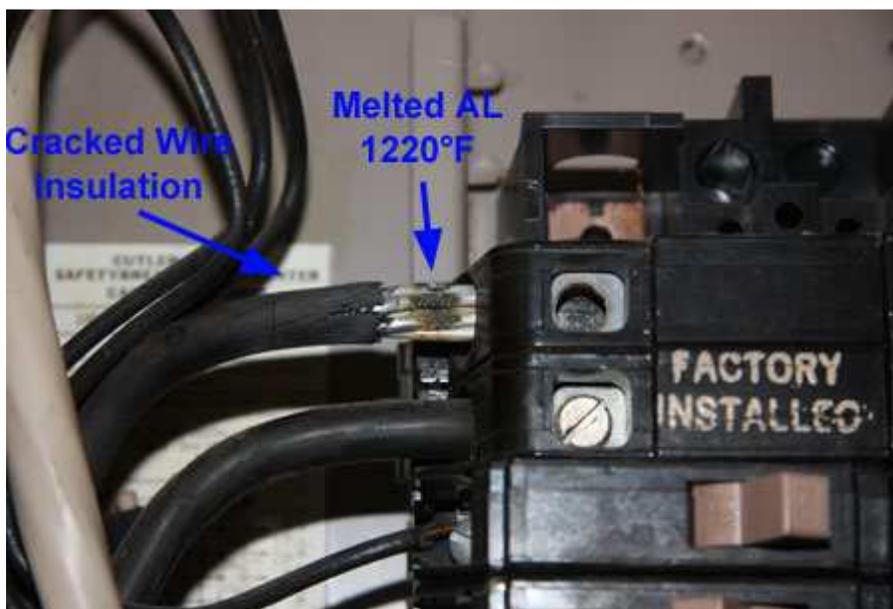
The Heat from the Loose Electrical Connection has cracked the Wire Insulation and the Aluminum Conductor is starting to melt (F09-028).

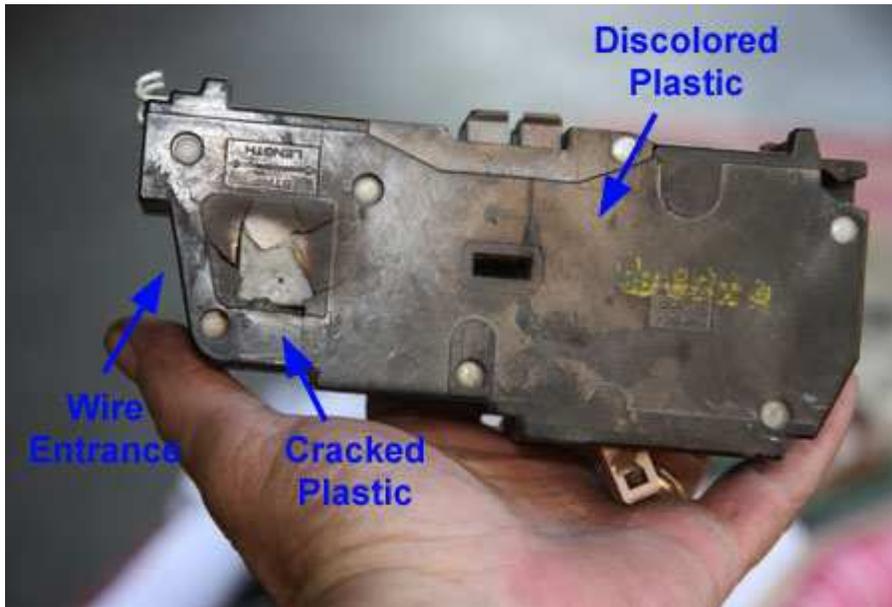
The Plastic on the Bottom of the Circuit Breaker was Cracked and Discolored (F09-028).

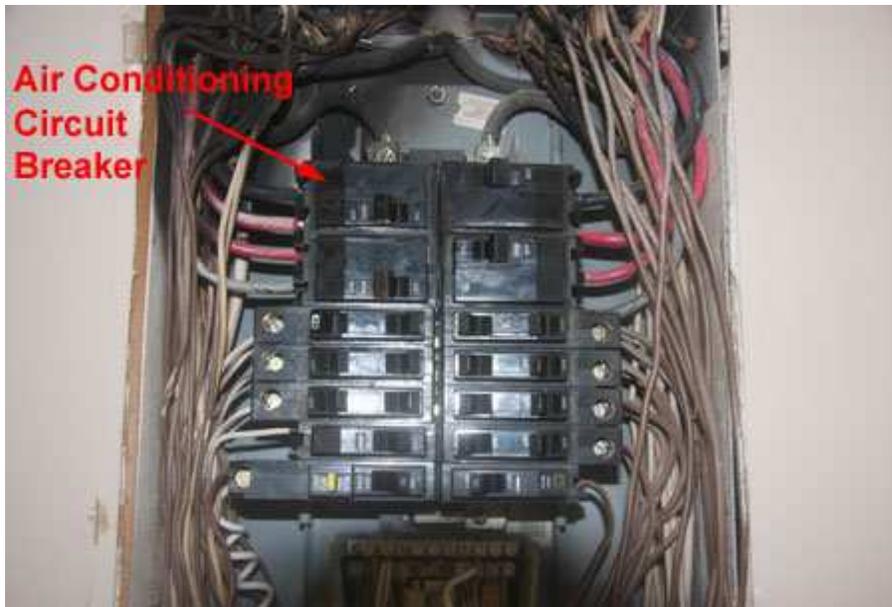
The day before this fire, the homeowner heard a cracking sound whenever the central air conditioning came on. The next day, a small fire occurred when an electrician was tightening the screws in the panel box.

Looking at the Front of the Electrical Distribution Panel, there appeared to be no Damage (F09-045).

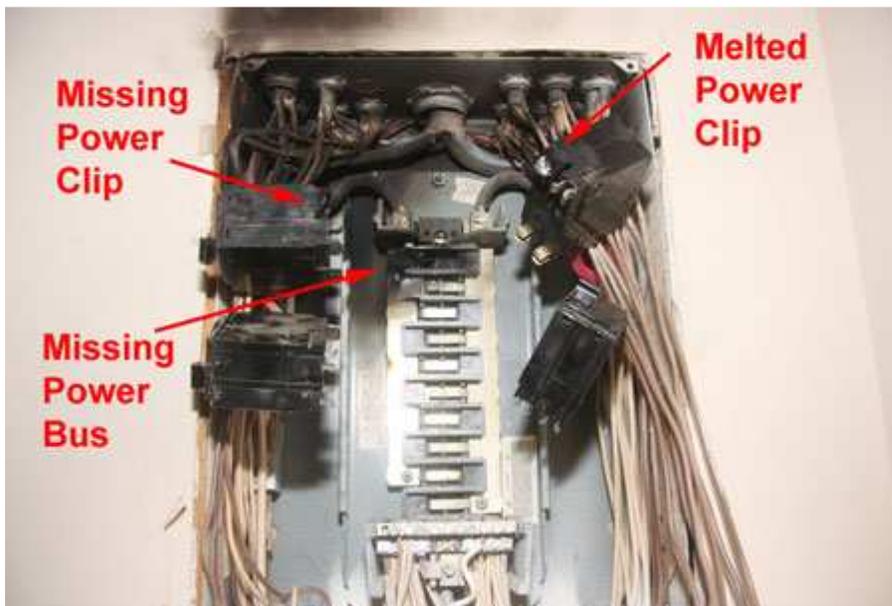
One of the Power Clips on the AC Circuit Breaker was Missing, Part of the Power Bus was Missing and Melting of a Power Clip.

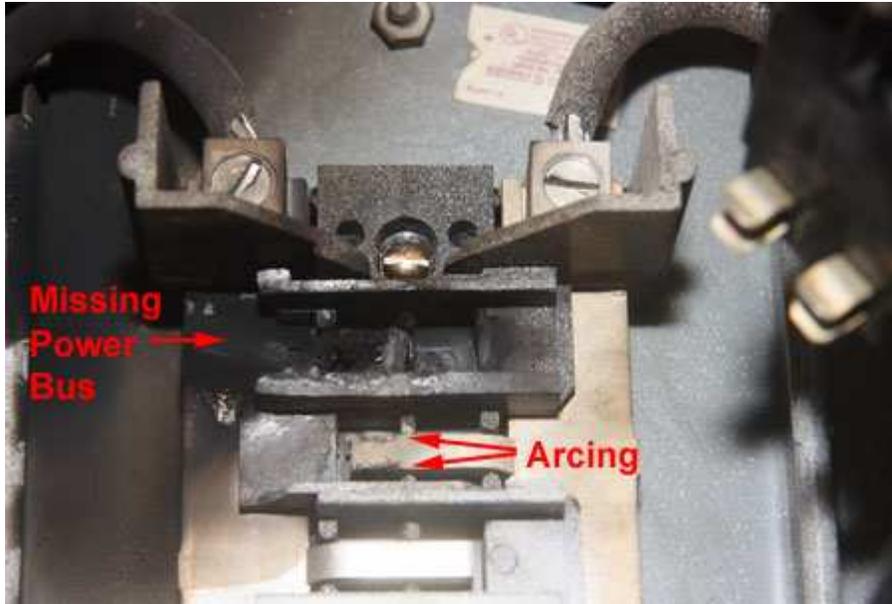
Missing Power Bus and Arcing on the Power Bus Immediately below the Missing Bus (F09-045).

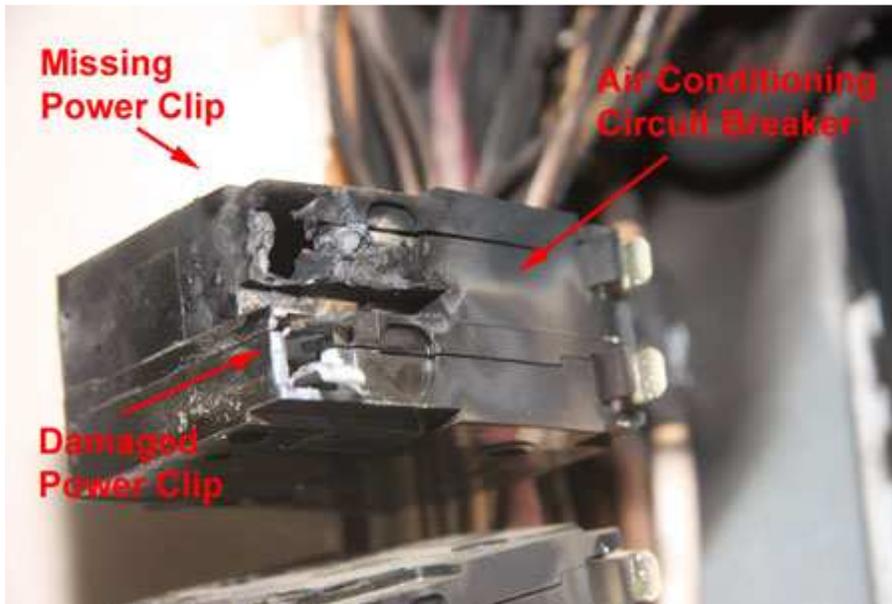
Missing Top Power Clip and Melting on the Bottom Power Clip of the AC Circuit Breaker (F09-045).

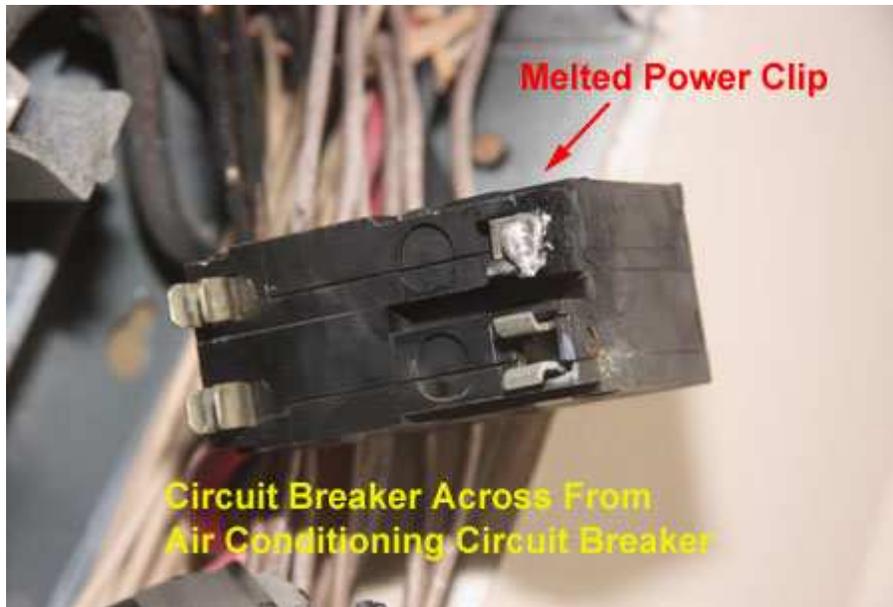
The Circuit Breaker Across from the AC Circuit Breaker shared the same Power Bus, and its Top Clip was melted (F09-045).

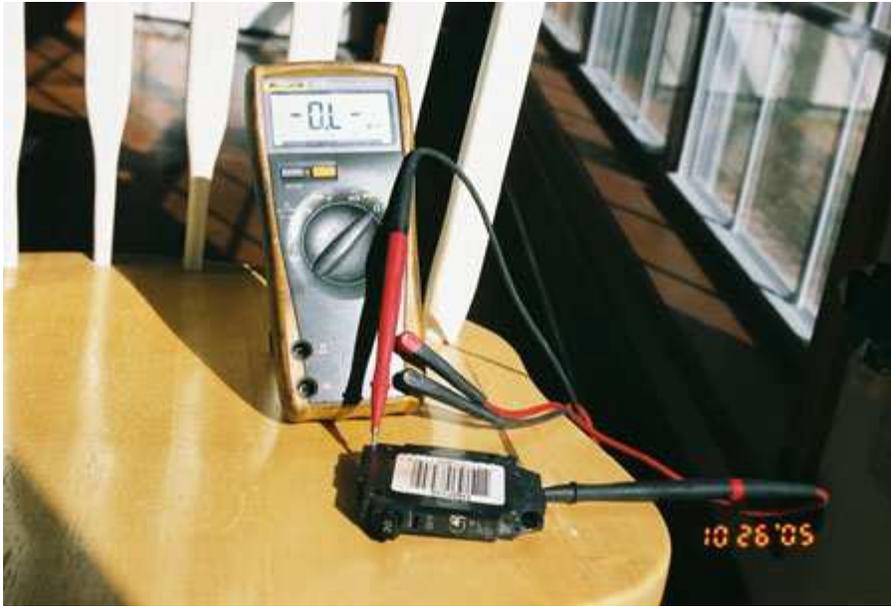
A one-half size GE circuit breaker was repeatedly tripping at a RV hookup. The paper barcode on the circuit breaker had started to turn brown. The problem was traced to the contacts inside the circuit breaker being misaligned.

No Continuity with GE Circuit Breaker in "ON" Position.

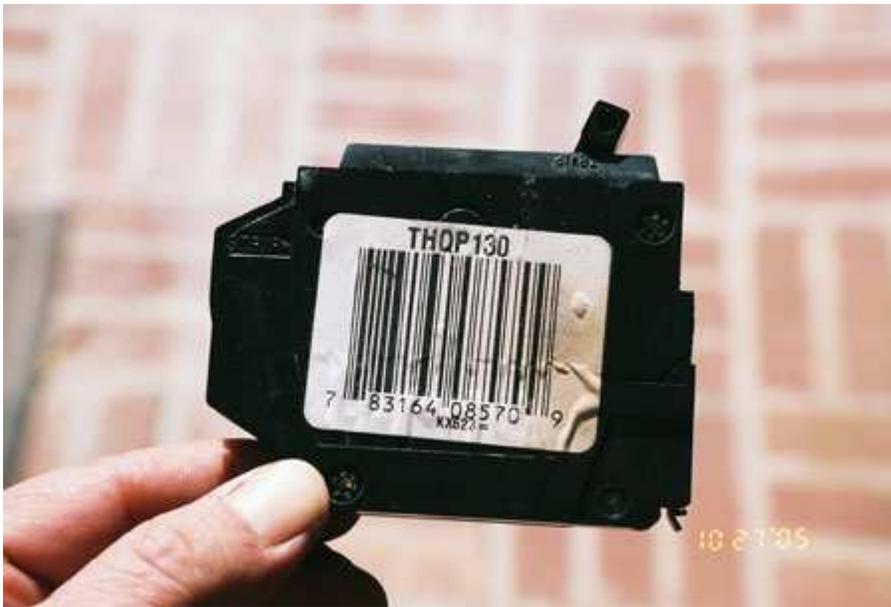
Brown Area on Barcode Label Indicating Excessive Heat.

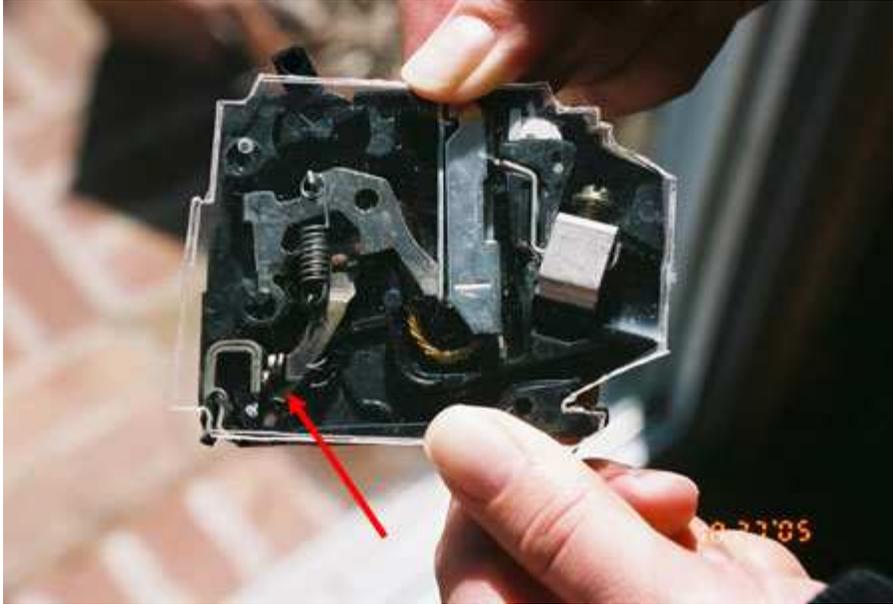
GE Circuit Breaker with Cover Removed - Contacts Not Aligned.

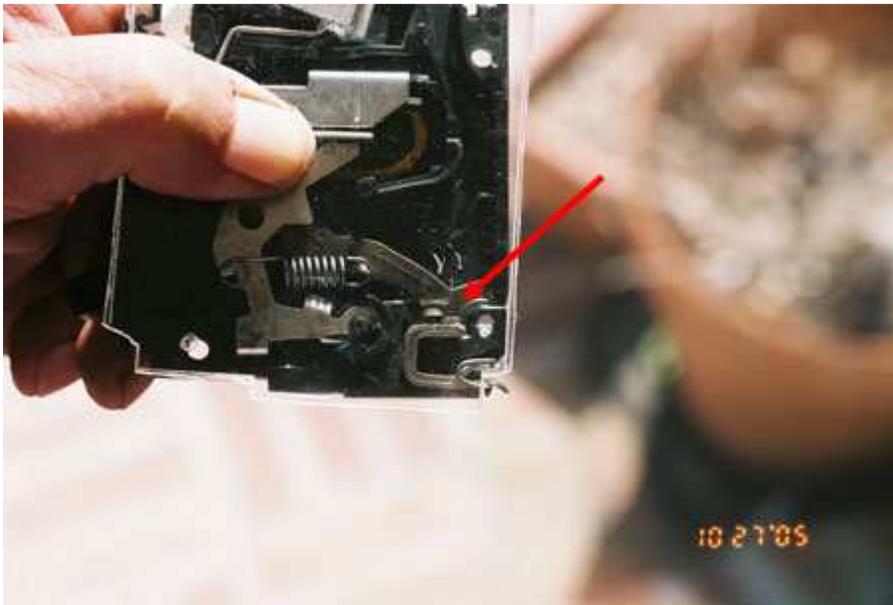
Side View of GE Circuit Breaker with Misaligned Contacts.

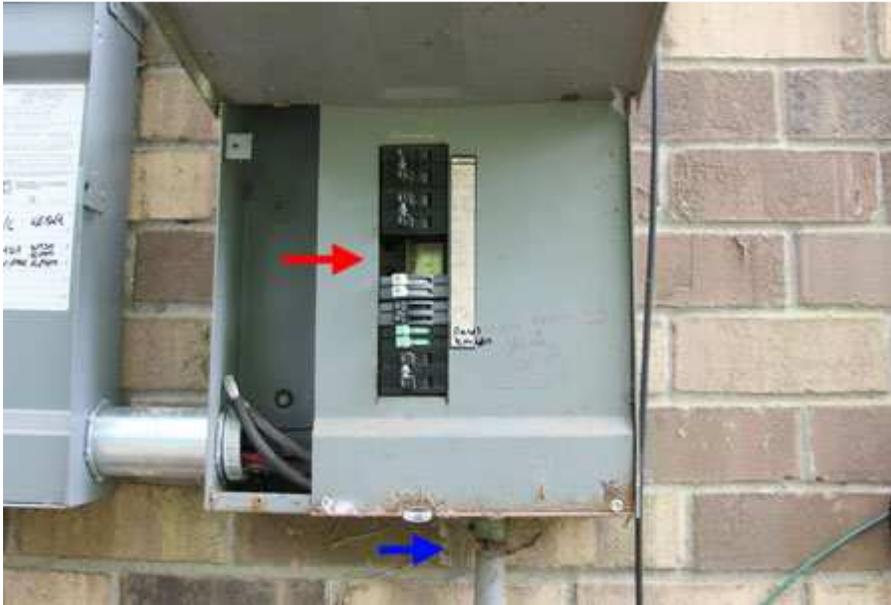
Zinsco circuit breakers are notorious for arcing and welding to the aluminum power bus. Even though this homeowner worked for an electric utility company, he allowed

Zinsco Panel Box with Missing Circuit Breaker (F09-026).

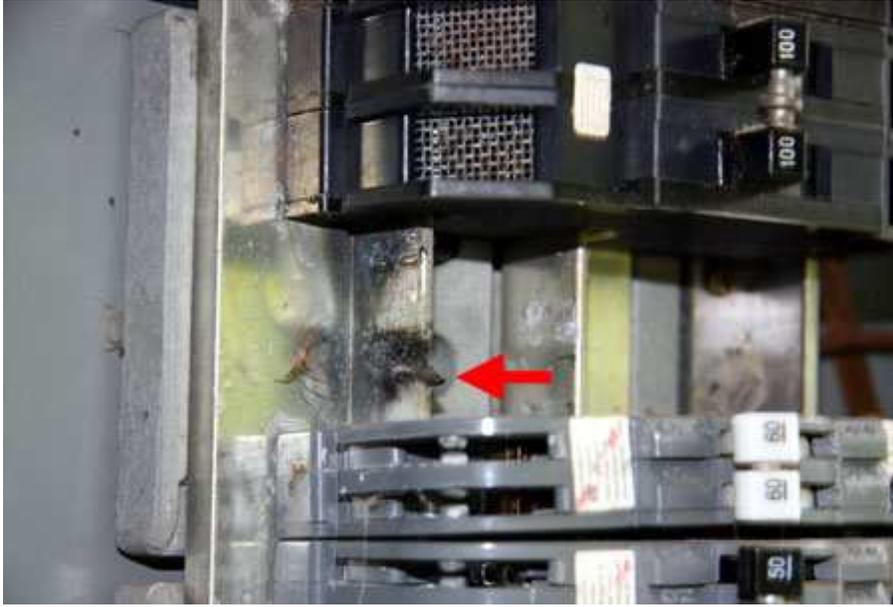
Damage to Power Bus as a Result of Arcing (F09-026).

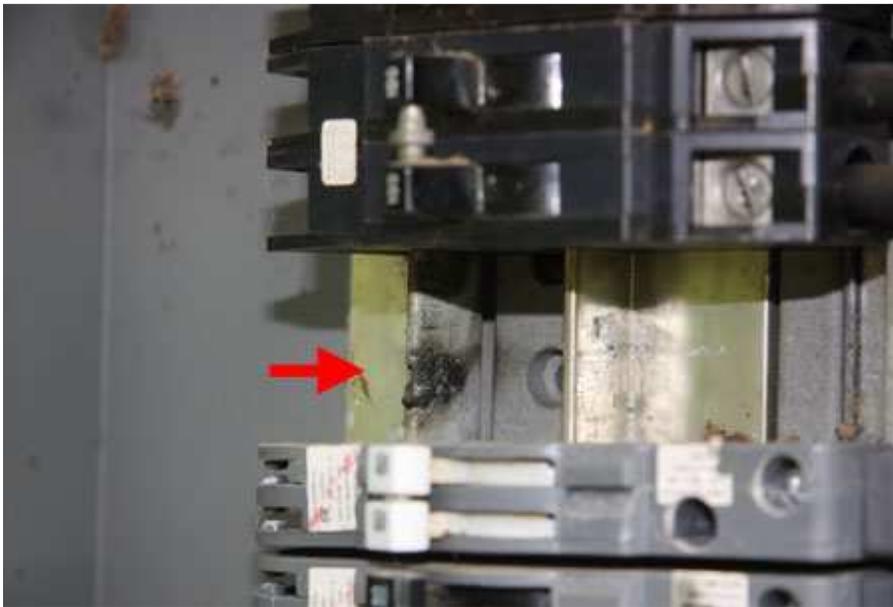
Melting on the Zinceo Power Bus as a Result of Arcing (F09-026).
