## POLYBUTYLENE PIPE

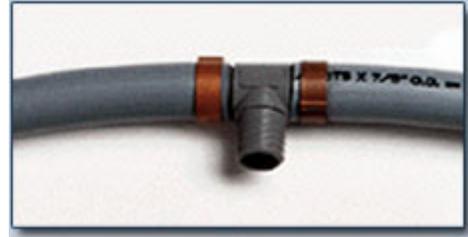
Polybutylene pipe is easily recognized by its bluish gray or white color.

**Interior Polybutylene piping systems shown with copper fittings (left) and Plastic acetal fittings (right).**

What causes polybutylene pipes to deteriorate can be attributed to the oxidants in the water. With the increased usage of chemicals like chlorine and other bacteria fighting ingredients significantly more failures occurred. These oxidants react with the polybutylene making it brittle and help in the development of micro cracks in the pipe. Just looking at the pipes may not give you any indication that there is a problem because the erosion and cracks start on the inside of the pipe. **Be aware, what appears to be okay, may not be!**
